**Climate Proofing Housing Landscapes:  
Monitoring Report 2**

**June 2016 to September 2016**

**Authors: Connop, S., Clough, J., Gunawardena, D. and Nash, C.**

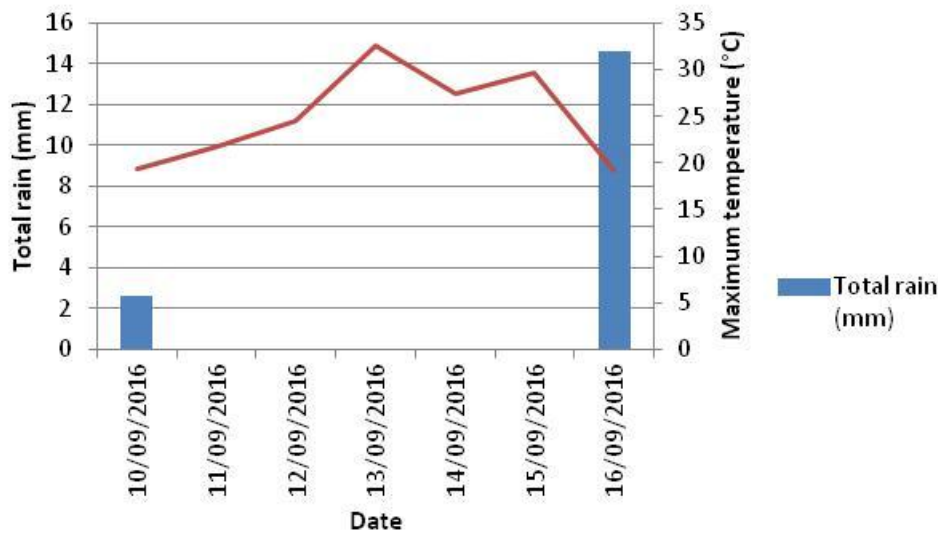
**Figure 80. Prevailing weather conditions preceding one of the five largest rain events at Queen Caroline Estate, Hammersmith.** Rain event was 14.6 mm on 16th September 2016.
